**Flood Control Project Maintenance
Levee Inspections**
LMA District Cover Sheet
Spring 2016 Levee Inspection Results

City of Sacramento

Spring 2016 Levee Inspection Results

Waterway			Bank	Unit Miles
Unit No. 01 Sacramento River			Left	3.67
	Spring (March - May)	Summer (June - August)	(September - November) Fall	Winter (December - February)
Unit Maintenance Rating (Fall Only)				
Date of Inspection	3/8/2016 - 3/8/2016			
DWR Inspector	Jai Lor			
Accompanied By	Michael Gonsalves City of Sacramento

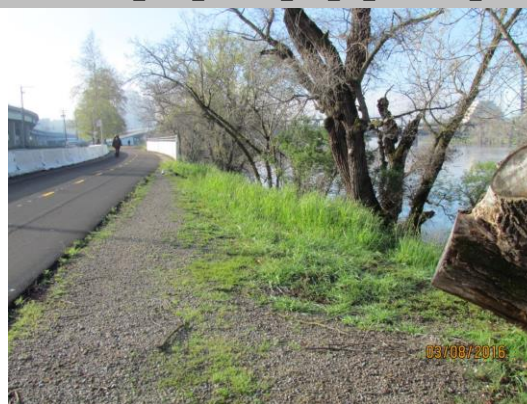
Photo 1 of 1 : SP_2016_NA0005_251_77_20160308_00113.jpg

View of the vegetation on the waterward side of the levee looking downstream. Spring 2016.

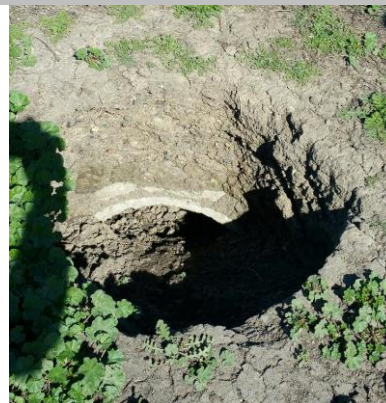
Photo 1 of 2 : UCIP_SP_2016_47162_74943.jpg

LM Start	0.06	Rating **	M	Issue No.	885
LM End	0.06	Issue Type +	En	Location *	WS
Category	Supplemental			GPS Latitude/Longitude	
				Start	End
Item	DWR UCIP Field Study			38.589864 °	38.589864 °
				-121.505128 °	-121.505128 °
DWR ID					
Comment Code					
Inspector Comment					
FS_ID:47162 DS_ID:21559 EP_NO: 14527 Repair Type: Non-Urgent Crossing Status: Found UCIP Comments: 3-22-16 Testing UCIP web app.Need to contact owner to determine condition of crossing and last inspection date. FIELD_STRUCT_DESC: 12-inch diameter pipeline under channel through levee, 44 feet below the crown. Southern Pacific Pipe Lines. (Permit No. 14527, Southern Pacific Pipelines, Inc.-1987). FS Date: 3/22/2016 8:55:57 AM

Sink hole that was found.

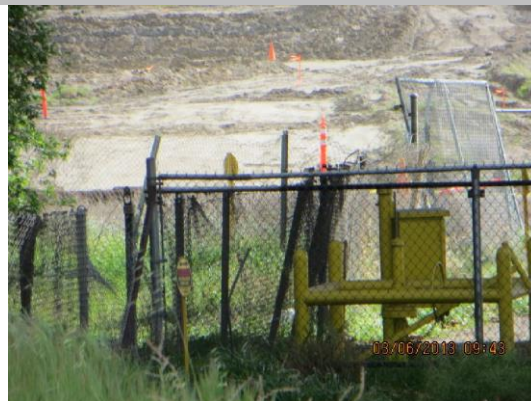
Photo 2 of 2 : UCIP_SP_2016_47162_33805.jpg

View of multiple markers indicating gas alignment.

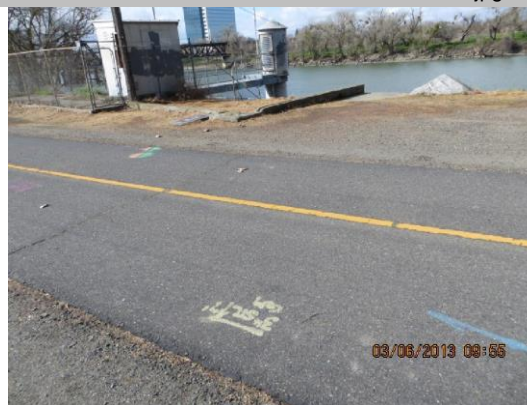
Photo 1 of 2 : UCIP_SP_2016_41414_72622.jpg

LM Start	0.14	Rating **	M	Issue No.	830
LM End	0.14	Issue Type +	En	Location *	WS
Category	Supplemental			GPS Latitude/Longitude	
				Start	End
Item	DWR UCIP Field Study			38.588768 °	38.588768 °
				-121.504891 °	-121.504891 °
DWR ID					
Comment Code					
Inspector Comment					
FS_ID:41414 DS_ID:24882 EP_NO: N/A Repair Type: Non-Urgent Crossing Status: Indicator Found UCIP Comments: Need to contact owner to determine status of crossing. No permit found during desk study review. FIELD_STRUCT_DESC: 42 inch water transmission main through levee at unknown depth. Crossing installed in 1966. FS Date: 3/6/2013

View of levee crown and waterward side.

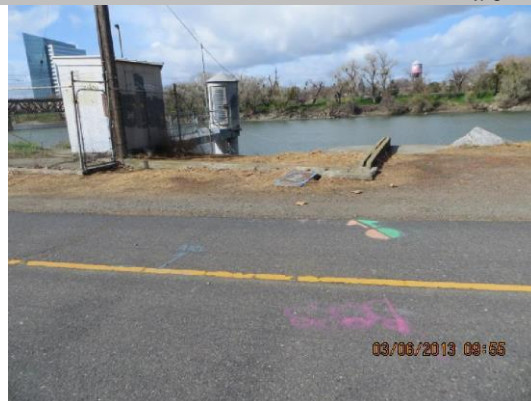
Photo 2 of 2 : UCIP_SP_2016_41414_72621.jpg

Underground Service Alert (USA) markings indicating 42 inch line through levee.

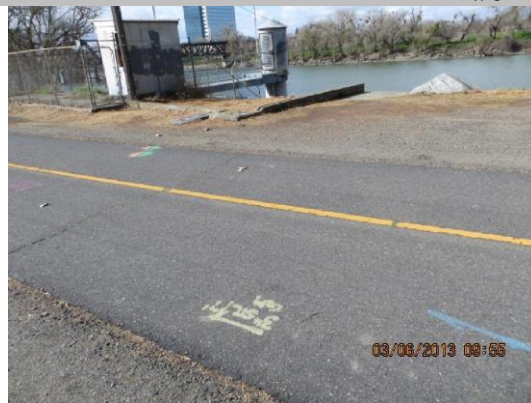
Photo 1 of 2 : UCIP_SP_2016_41415_72630.jpg

LM Start	0.14	Rating **	M	Issue No.	831
LM End	0.14	Issue Type +	En	Location *	WS
Category	Supplemental			GPS Latitude/Longitude	
				Start	End
Item	DWR UCIP Field Study			38.588738 °	38.588738 °
				-121.504891 °	-121.504891 °
DWR ID					
Comment Code					
Inspector Comment					
FS_ID:41415 DS_ID:24883 EP_NO: N/A Repair Type: Non-Urgent Crossing Status: Indicator Found UCIP Comments: Need to contact owner to confirm alignment and status of crossings. No permit found during desk study review. FIELD_STRUCT_DESC: ARV communication line and 3-inch STL communication line on levee. FS Date: 3/6/2013

Underground Service Alert (USA) markers visible on levee crown.

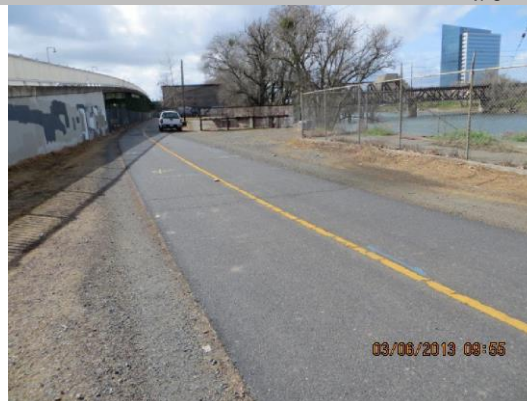
Photo 2 of 2 : UCIP_SP_2016_41415_72623.jpg

Overview of levee crown looking downstream.

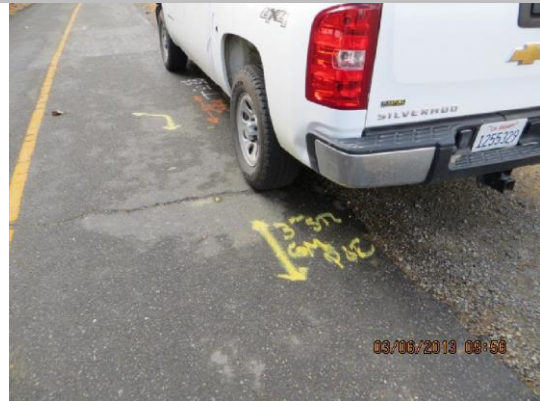
Photo 2 of 2 : UCIP_SP_2016_47163_72626.jpg

LM Start	0.15	Rating **	U	Issue No.	886 (cont)
LM End	0.15	Issue Type +	En	Location *	WS
Category	Supplemental			GPS Latitude/Longitude	
				Start	End
Item	DWR UCIP Field Study			38.588636 °	38.588636 °
				-121.504860 °	-121.504860 °
DWR ID					
Comment Code					
Inspector Comment					
FS_ID:47163 DS_ID:24884 EP_NO: N/A Repair Type: Urgent Crossing Status: Indicator Found UCIP Comments: 3/22/16 Testing how to use ucip.No markers found. Need to contact owner to determine status of crossing and to determine last inspection date. FIELD_STRUCT_DESC: PG&E line though levee at unknown depth. FS Date: 3/22/2016 8:54:29 AM

Underground Service Alert (USA) markings of PG&E line through levee, Photo 1 of 2.

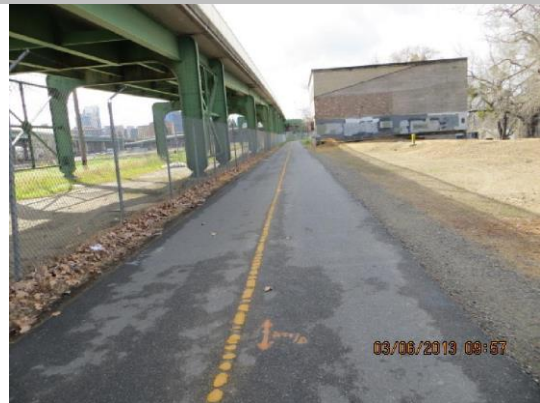
Photo 1 of 2 : UCIP_SP_2016_41416_72629.jpg

LM Start	0.16	Rating **	M	Issue No.	832
LM End	0.16	Issue Type +	En	Location *	WS
Category	Supplemental			GPS Latitude/Longitude	
				Start	End
Item	DWR UCIP Field Study			38.588500 °	38.588500 °
				-121.504856 °	-121.504856 °
DWR ID					
Comment Code					
Inspector Comment					
FS_ID:41416 DS_ID:24885 EP_NO: N/A Repair Type: Non-Urgent Crossing Status: Indicator Found UCIP Comments: No markers visible as per Title 23. Recommend having utility owner coordinate with Central Valley Flood Protection Board (CVFPB). FIELD_STRUCT_DESC: ATT communication line through levee at unknown depth. FS Date: 3/6/2013

Alignment of communication line through levee, Photo 1 of 2.

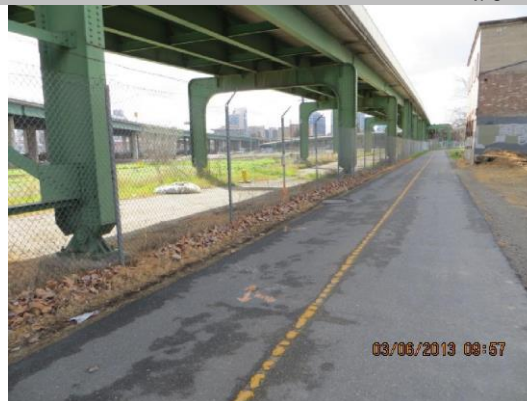
Photo 2 of 2 : UCIP_SP_2016_41416_72628.jpg

Alignment of communication line through levee, Photo 2 of 2.

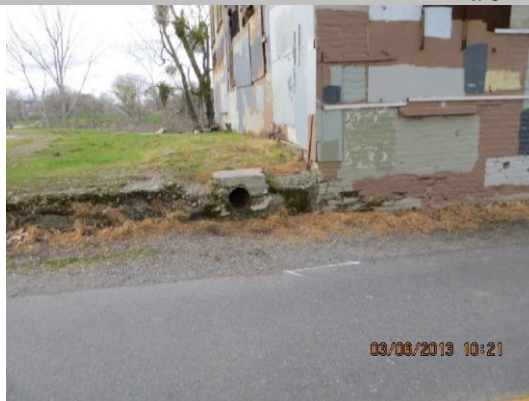
Photo 1 of 2 : UCIP_SP_2016_40848_72633.jpg

LM Start	0.22	Rating **	M	Issue No.	861
LM End	0.22	Issue Type +	En	Location *	WS
Category	Supplemental			GPS Latitude/Longitude	
				Start	End
Item	DWR UCIP Field Study			38.587615 °	38.587615 °
				-121.505034 °	-121.505034 °
DWR ID					
Comment Code					
Inspector Comment					
FS_ID:40848					
DS_ID:24887					
EP_NO: N/A					
Repair Type: Non-Urgent					
Crossing Status: Indicator Found					
UCIP Comments: Pump station appears non-functional. Owner will need to coordinate with DWR-Inspector and CVFPB to determine if crossing meets Title 23 requirements.					
FIELD_STRUCT_DESC: 12 inch connected to 10 inch pipe through levee at unknown depth.					
FS Date: 3/6/2013

Pipe through levee visible next to building located on levee.

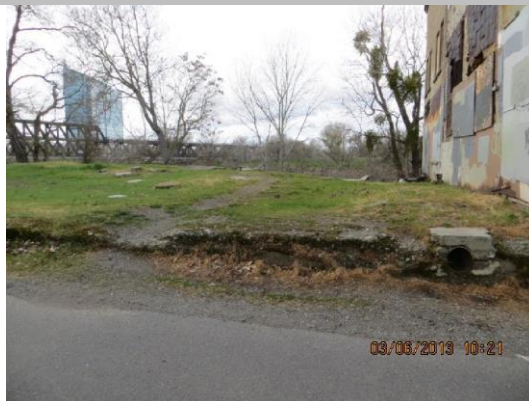
Photo 2 of 2 : UCIP_SP_2016_40848_72632.jpg

View of levee crown at crossing.

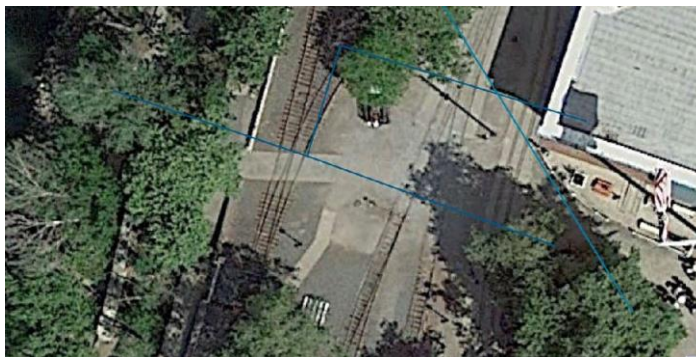
Photo 1 of 1 : UCIP_SP_2016_41247_72740.jpg

LM Start	0.42	Rating **	M	Issue No.	866
LM End	0.42	Issue Type +	En	Location *	WS
Category	Supplemental			GPS Latitude/Longitude	
				Start	End
Item	DWR UCIP Field Study			38.584794 °	38.584794 °
				-121.505548 °	-121.505548 °
DWR ID					
Comment Code					
Inspector Comment					
FS_ID:41247					
DS_ID:24889					
EP_NO: N/A					
Repair Type: Non-Urgent					
Crossing Status: Indicator Found					
UCIP Comments: Unable to confirm if crossing exists. Approximate alignment provided by the City of Sacramento. Need to confirm alignment and status of crossing.					
FIELD_STRUCT_DESC: 10 inch pipe through levee. Record was obtained from Sacramento County approximate utility alignment.					
FS Date: 3/6/2013

Alignment provided by City of Sacramento of 10 inch line--not found during field inspection.

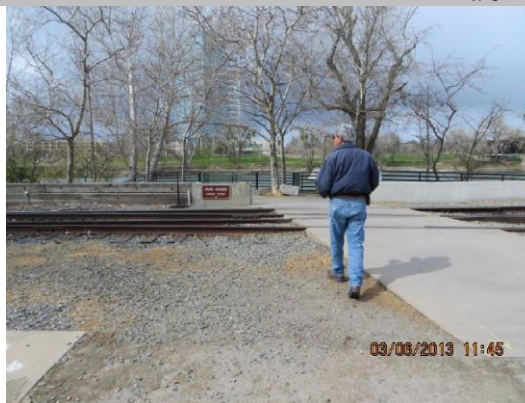
Photo 1 of 2 : UCIP_SP_2016_20384_34410.jpg

LM Start	0.42	Rating **	M	Issue No.	828
LM End	0.42	Issue Type +	En	Location *	WS
Category	Supplemental			GPS Latitude/Longitude	
				Start	End
Item	DWR UCIP Field Study			38.584762 °	38.584762 °
				-121.505556 °	-121.505556 °
DWR ID					
Comment Code					
Inspector Comment					
FS_ID:20384 DS_ID:21561 EP_NO: N/A Repair Type: Non-Urgent Crossing Status: Indicator Found UCIP Comments: Only manhole was visible; need to determine condition of crossing; Will need to follow up with the City of Sacramento. FIELD_STRUCT_DESC: 18-inch-diameter storm drain through the levee, 5 feet below the crown. Concrete surge box on the waterward side of the retaining wall. Concrete box spillway. FS Date: 3/6/2013

View of levee crown downtown Sacramento--wide crown with railroad.

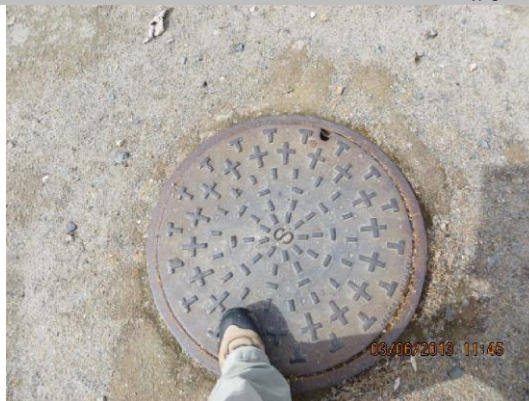
Photo 2 of 2 : UCIP_SP_2016_20384_34409.jpg

View of manhole located at the edge of waterward.

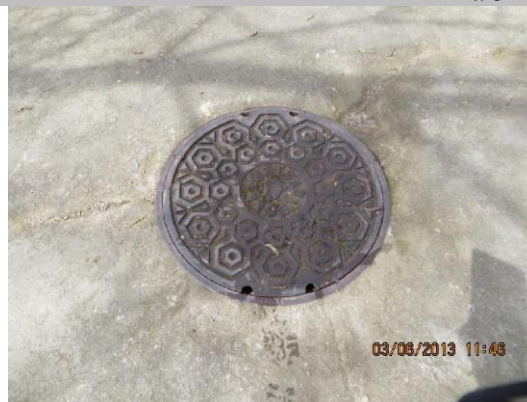
Photo 1 of 2 : UCIP_SP_2016_41417_72642.jpg

LM Start	0.42	Rating **	M	Issue No.	833
LM End	0.42	Issue Type +	En	Location *	WS
Category	Supplemental			GPS Latitude/Longitude	
				Start	End
Item	DWR UCIP Field Study			38.584767 °	38.584767 °
				-121.505700 °	-121.505700 °
DWR ID					
Comment Code					
Inspector Comment					
FS_ID:41417 DS_ID:24890 EP_NO: N/A Repair Type: Non-Urgent Crossing Status: Indicator Found UCIP Comments: Need additional information about crossing--depth of pipe, owner, status, and permit. FIELD_STRUCT_DESC: Submarine cable from the bed of the Sacramento River through and along the natural west levee of the river at a depth of 2 feet to a point in the town of Broderick, opposite a point approximately 434 feet downstream from the "I" Street Bridge, Sacramento. (Permit No. 881, 1942) FS Date: 3/6/2013

PacBell manhole located on waterward side.

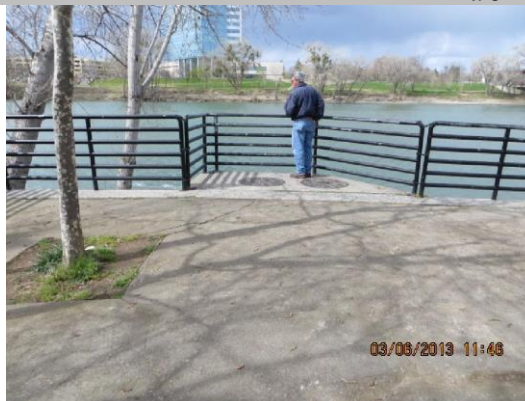
Photo 2 of 2 : UCIP_SP_2016_41417_72641.jpg

Manholes located along levee--waterward side.

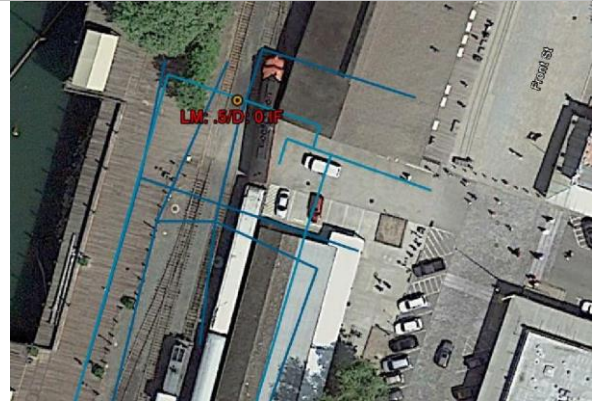
Photo 1 of 1 : UCIP_SP_2016_41418_72741.jpg

LM Start	0.50	Rating **	M	Issue No.	834
LM End	0.50	Issue Type +	En	Location *	WS
Category	Supplemental			GPS Latitude/Longitude	
				Start	End
Item	DWR UCIP Field Study			38.583693 °	38.583693 °
				-121.505909 °	-121.505909 °
DWR ID					
Comment Code					
Inspector Comment					
FS_ID:41418 DS_ID:24894 EP_NO: N/A Repair Type: Non-Urgent Crossing Status: Indicator Found UCIP Comments: Need to confirm status of crossing and alignment through levee. Unable to find permit during review. FIELD_STRUCT_DESC: 8 inch pipe through levee and along waterward side for about 800 feet. Crosses levee again at 38.581544, -121.506688. FS Date: 3/6/2013

Aproximate alignment provided by City of Sacramento -- unable to confirm if crossing is active.

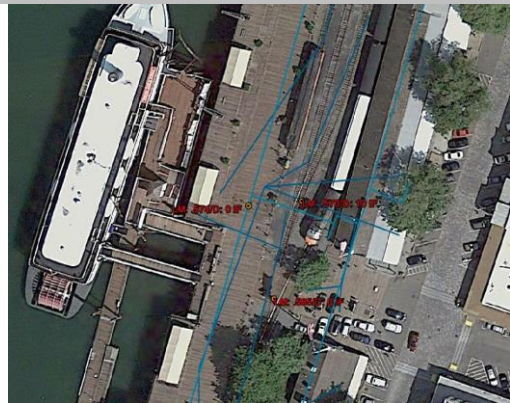
Photo 1 of 1 : UCIP_SP_2016_41419_72742.jpg

LM Start	0.57	Rating **	M	Issue No.	835
LM End	0.57	Issue Type +	En	Location *	WS
Category	Supplemental			GPS Latitude/Longitude	
				Start	End
Item	DWR UCIP Field Study			38.582700 °	38.582700 °
				-121.506266 °	-121.506266 °
DWR ID					
Comment Code					
Inspector Comment					
FS_ID:41419					
DS_ID:24895					
EP_NO: N/A					
Repair Type: Non-Urgent					
Crossing Status: Indicator Found					
UCIP Comments: Need to confirm if crossing is still present. No signs visible during site visit. No photos available.					
FIELD_STRUCT_DESC: 10 inch line through levee. Record found in Sacramento County GIS records.					
FS Date: 3/6/2013

Approximate alignment provided by the City of Sacramento--unable to confirm crossing in field.

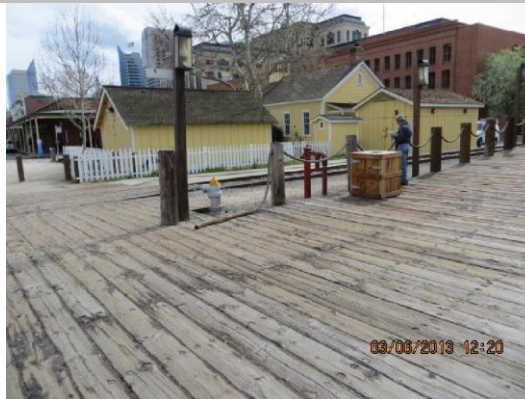
Photo 1 of 1 : UCIP_SP_2016_41266_72747.jpg

LM Start	0.67	Rating **	M	Issue No.	869
LM End	0.67	Issue Type +	En	Location *	WS
Category	Supplemental			GPS Latitude/Longitude	
				Start	End
Item	DWR UCIP Field Study			38.581332 °	38.581332 °
				-121.506853 °	-121.506853 °
DWR ID					
Comment Code					
Inspector Comment					
FS_ID:41266 DS_ID:24900 EP_NO: N/A Repair Type: Non-Urgent Crossing Status: Indicator Found UCIP Comments: Unable to confirm if crossing goes through levee. Need to contact owner to determine alignment for crossing. FIELD_STRUCT_DESC: Fire hydrant visible on levee crown located in downtown Sacramento. FS Date: 3/6/2013

Fire hydrant visible on levee crown.

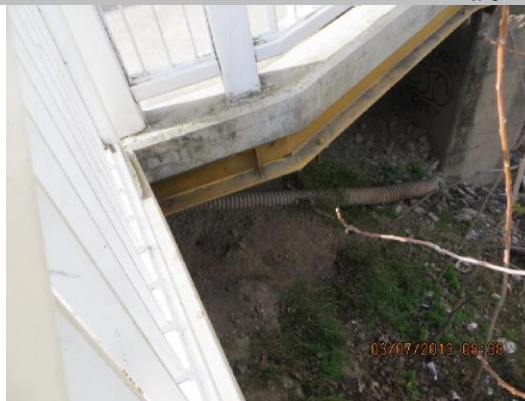
Photo 2 of 2 : UCIP_SP_2016_41421_72749.jpg

Pipe visible on waterward side.

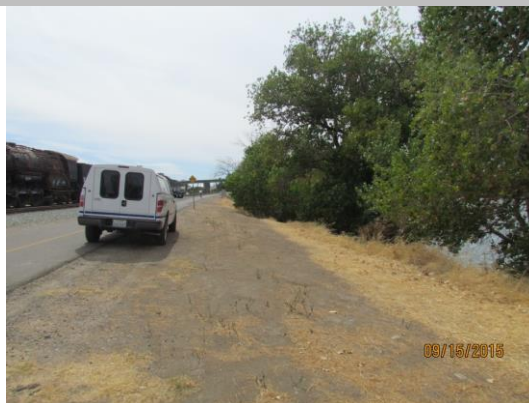
Photo 1 of 2 : SP_2016_NA0005_251_13_20160304_00010.jpg

Monitor trees and woody vegetation along the rivers edge looking downstream. Fall 2015.

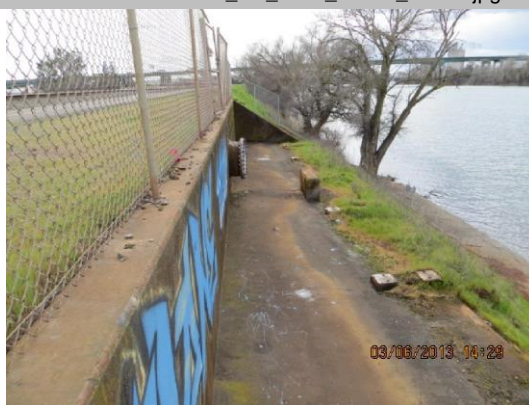
Photo 2 of 2 : UCIP_SP_2016_41425_34144.jpg

Headwall with 1 crossing capped off.

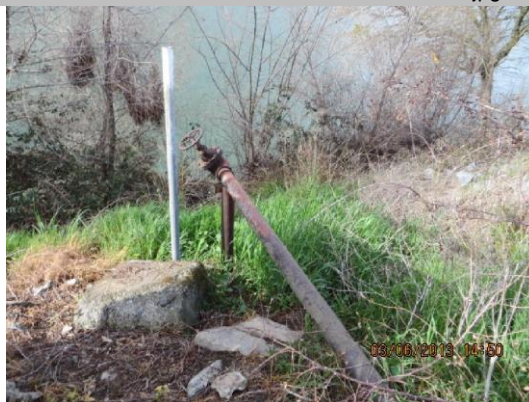
Photo 2 of 2 : UCIP_SP_2016_20105_34066.jpg

View of pipe and gate valve located on waterward slope.

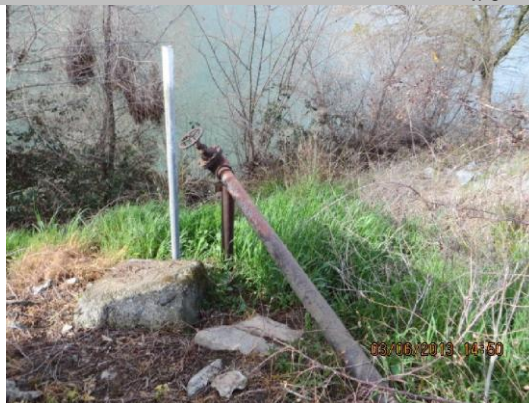
Photo 1 of 2 : UCIP_SP_2016_47164_34071.jpg

View of 6 inch pipe and shut-off valve located on waterward slope.

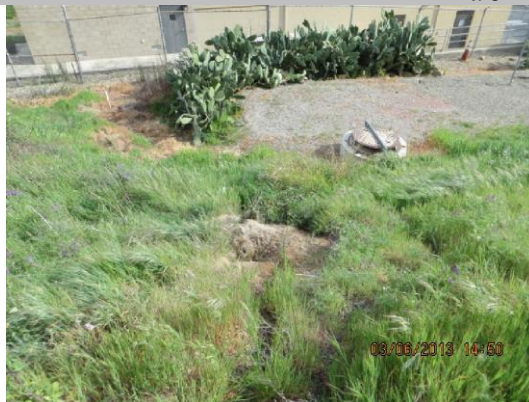
Photo 2 of 2 : UCIP_SP_2016_47164_34072.jpg

View of landward side--tall grass along slope limit inspection.

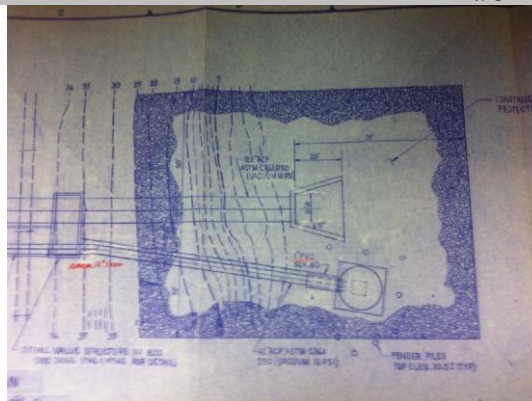
Photo 2 of 2 : UCIP_SP_2016_20087_34027.jpg

Rip rap protection around outfall structure for 42-inch and 120-inch pipes.

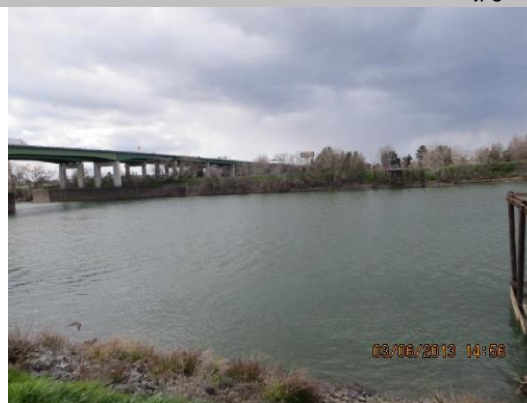
Photo 2 of 2 : UCIP_SP_2016_41280_34050.jpg

View of waterward side--outlet submerged.

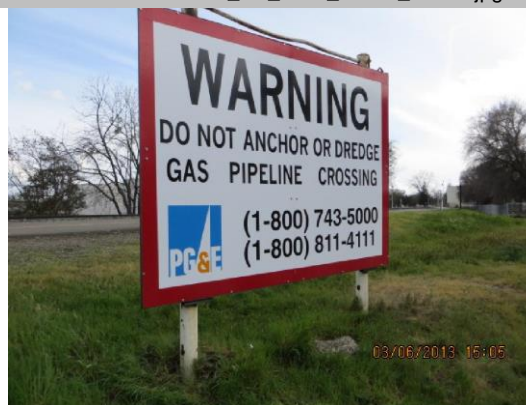
Photo 1 of 2 : UCIP_SP_2016_32883_59502.jpg

PG&E warning gas line crossing--waterward side view.

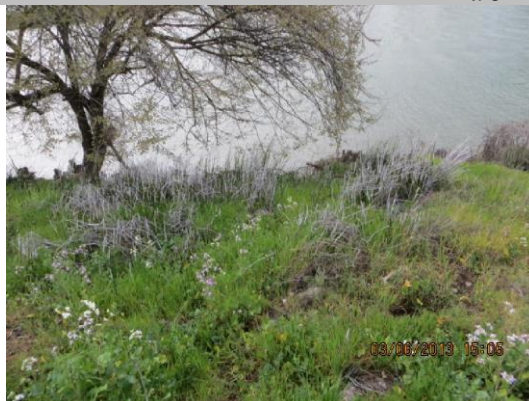
Photo 2 of 2 : UCIP_SP_2016_32883_59501.jpg

View of waterward slope--tall grass limits inspection.

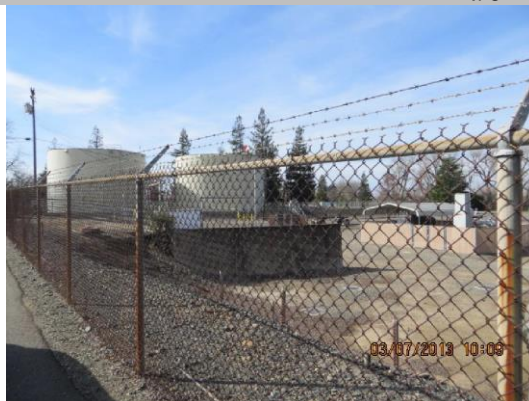
Photo 1 of 1 : UCIP_SP_2016_41444_59572.jpg

Concrete structure still remain in lot on waterward side.

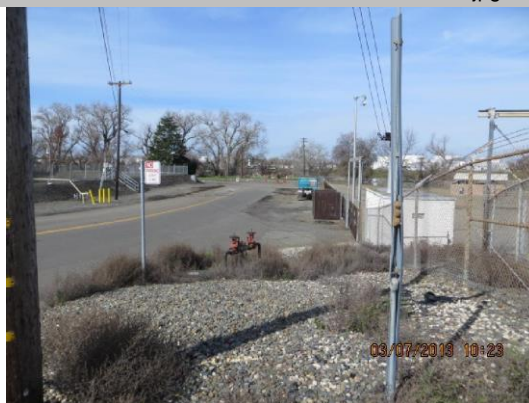
Photo 2 of 2 : UCIP_SP_2016_41427_59506.jpg

Backflow prevention device on shoulder.

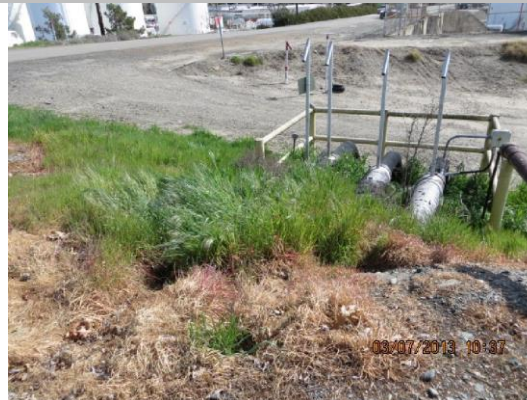
Photo 2 of 2 : UCIP_SP_2016_41452_59524.jpg

Dense burrow activity along landward slope.

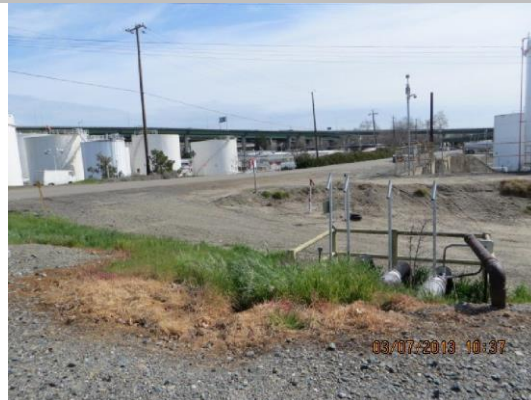
Photo 2 of 2 : UCIP_SP_2016_41448_59510.jpg

Overview of 4-10 inch lines through levee--landward side.

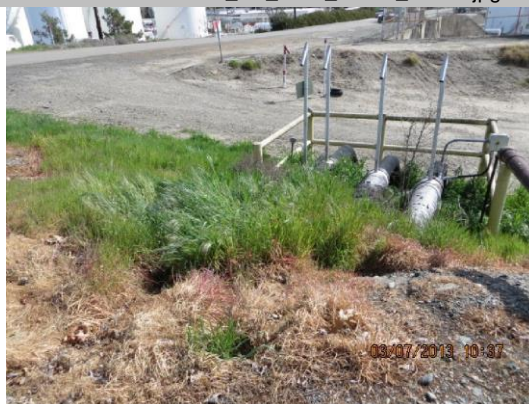
Photo 2 of 2 : UCIP_SP_2016_48322_59520.jpg

Dense burrow activity along levee slope.

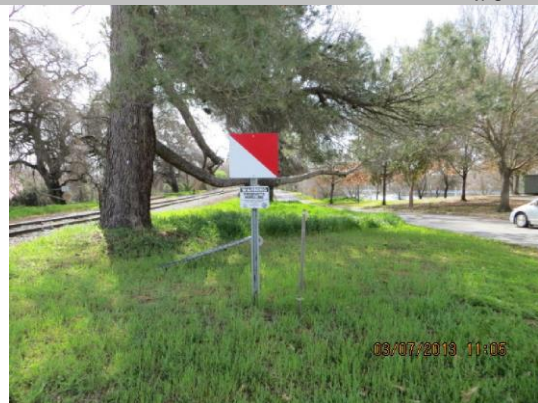
Photo 1 of 1 : UCIP_SP_2016_41291_72758.jpg

Marker of gas line visible on levee crown next to railroad tracks.

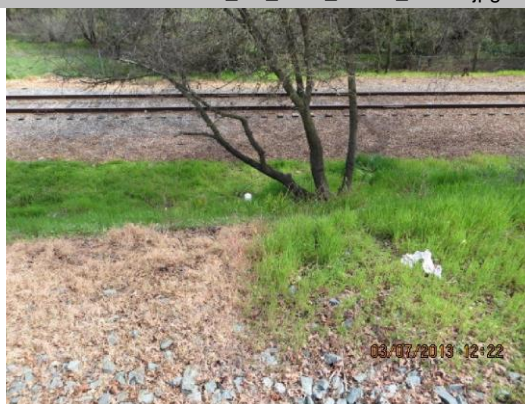
Photo 1 of 2 : UCIP_SP_2016_41293_72760.jpg

PVC pipe through levee.

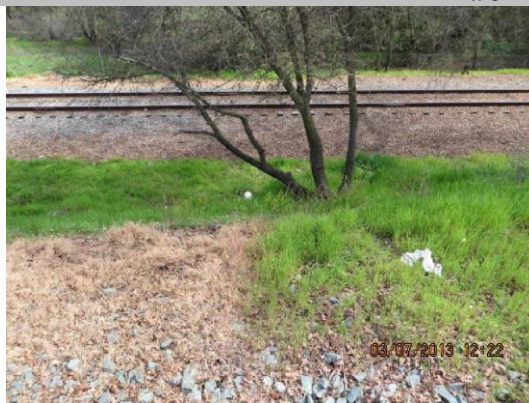
Photo 1 of 2 : UCIP_SP_2016_41294_72762.jpg

PVC pipe through levee.

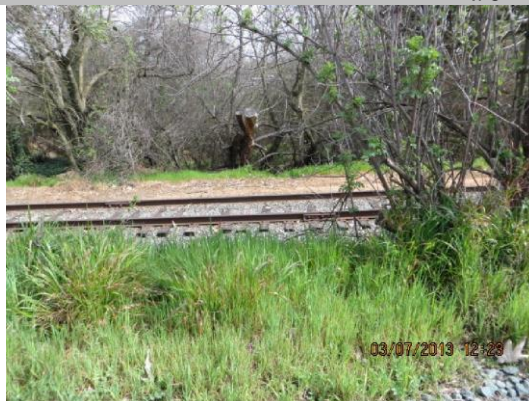
Photo 2 of 2 : UCIP_SP_2016_41295_72763.jpg

Dense vegetation along landward slope.

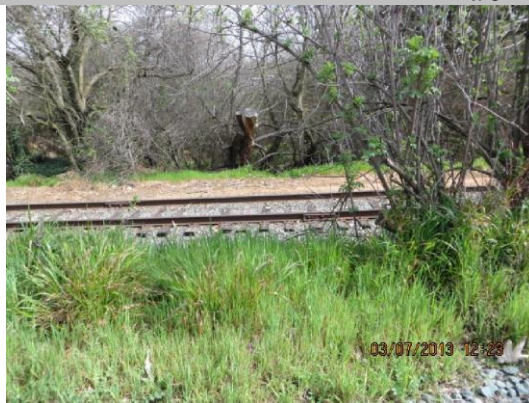
Photo 2 of 2 : UCIP_SP_2016_38827_72765.jpg

Dense vegetation on landward side.

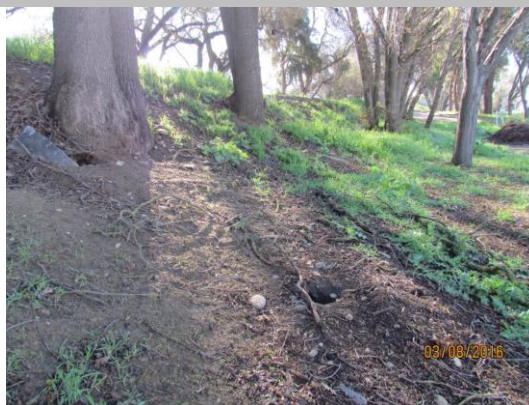
Photo 1 of 1 : SP_2016_NA0005_251_82_20160308_00117.jpg

View of the rodent holes on the waterward side of the levee looking downstream. Spring 2016.

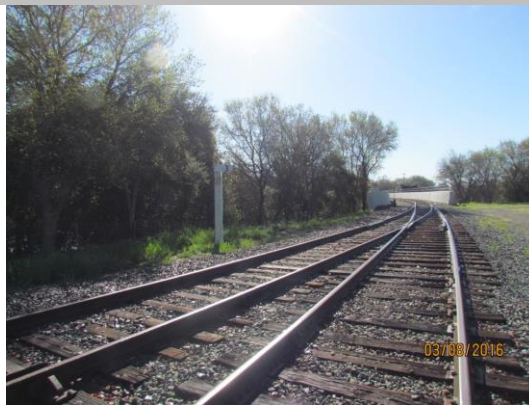
Photo 2 of 2 : SP_2016_NA0005_251_85_20160308_00120.jpg

Perspective view of the trees on the landward side of the levee looking downstream. Spring 2016.
